An Application of Infrared Thermography - Roofing Survey

*Palani Subramanian Perumal, Tan Lay Lian
AL Technologies (S) Pte Ltd, Singapore*

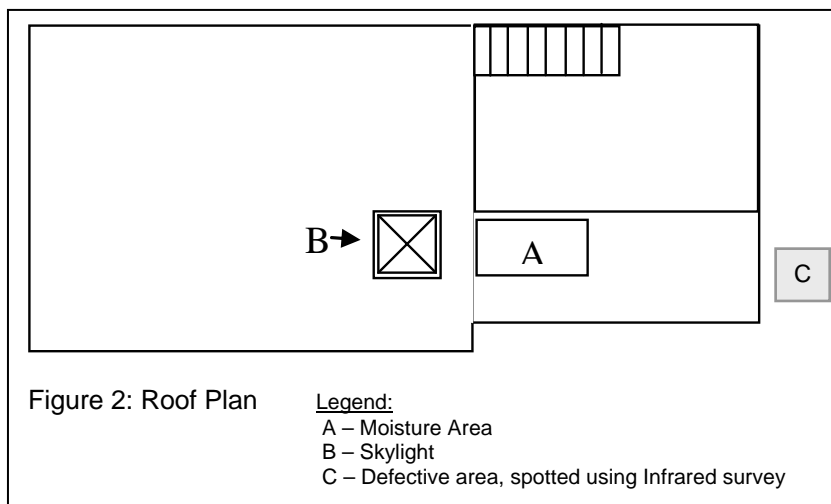
The project was carried out on the roof of a six storey building where moisture condensation was observed on the soffit of the 6th floor, so an investigation was undertaken to locate the cause of the problem via IR survey. Prior to the survey, the client conducted a visual inspection and assumed that the cause of the moisture condensation was poor sealant used to fix the rubber lining around the roof-light-glass panel on the 6th storey. After the infrared survey was conducted, the results revealed the actual problem areas were not what were suspected through the earlier visual inspection. Figure 2 shows the layout of the roof. Area A shows the observed moisture on the roof of the 5th story (soffit of the 6th story). Area B indicates skylight with rubber lining around. Area C indicates defective area, spotted using Infrared survey.

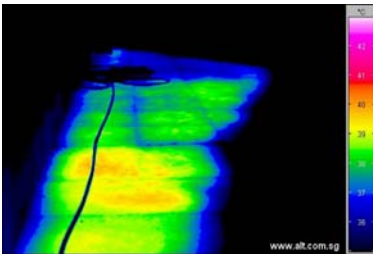
Figure 4: Hotspots on Roof

Initially, the hot roof surface did not indicate any hotspots because, there was no temperature difference between the wet and dry areas. As the roof surface started to cool down, the infrared camera could detect hotspots (Figure 4). The dry area cooled at a faster rate than the wet area, which contained trapped water.

The thermal images in figures 4 and 6 show the hotspots identified from the infrared survey and figure 5 shows the defective area. We observed from the thermal images that the temperature difference between the hotspots (yellow/red spots) and the rest of the area was about 4 degrees.
