An Application of Infrared Thermography - Roofing Survey

*Palani Subramanian Perumal, Tan Lay Lian
AL Technologies (S) Pte Ltd, Singapore*

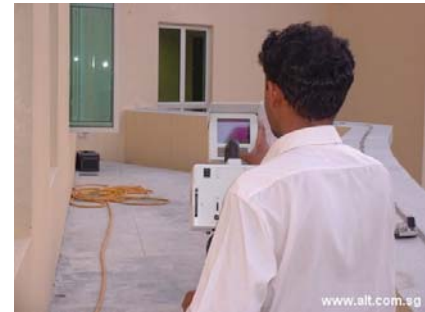
Figure 3: IR survey in progress

The roof was washed repeatedly with water in the morning to enable the water to penetrate and get trapped under the roofing surface. During the day, the sun heated up the roof surface. The investigation was carried out in the early evening about two hours after the sunset.

Initially, the hot roof surface did not indicate any hotspots because, there was no temperature difference between the wet and dry areas. As the roof surface started to cool down, the infrared camera could detect hotspots (Figure 4). The dry area cooled at a faster rate than the wet area, which contained trapped water.
